**Building Assessment Report**

Feb 28, 2026

Ref: Leu Civic Center  
213 N. Market St  
Mascoutah, IL

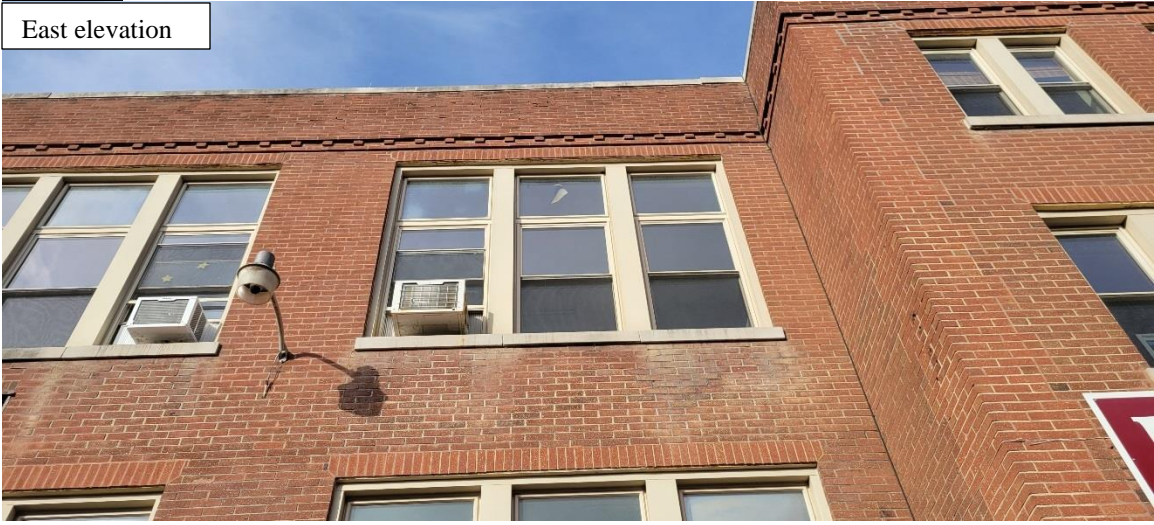
**Picture#1**

The exterior elevations are exhibiting excessive amount of water damage. At all elevations, there is noticeable staining that existing under the window openings. There is indication that water is entering the inside of the masonry wall at the window sill. Mortar joints are loose or even missing in these areas. There are additional areas below windows that exhibit (picture #6) loose or missing mortar joints. **See Pictures #1 thru #9.**

East elevation

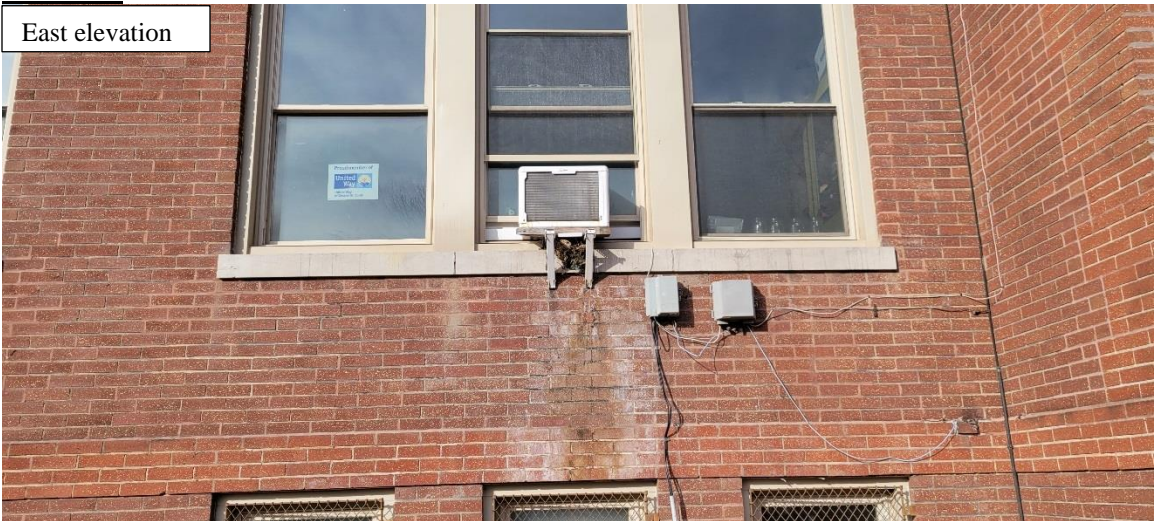
**Picture#2**

East elevation

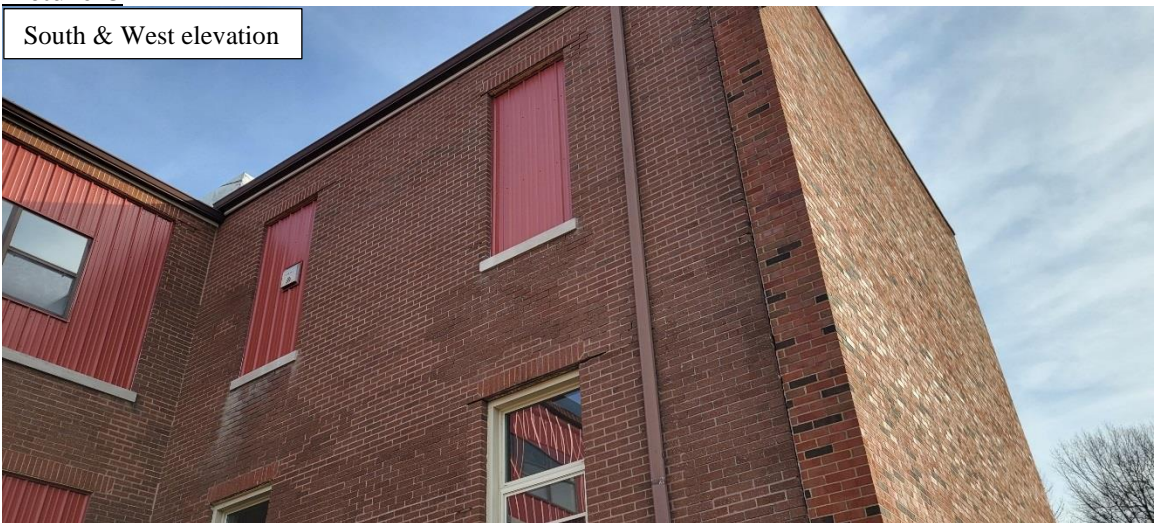
**Picture#3**

South & West elevation

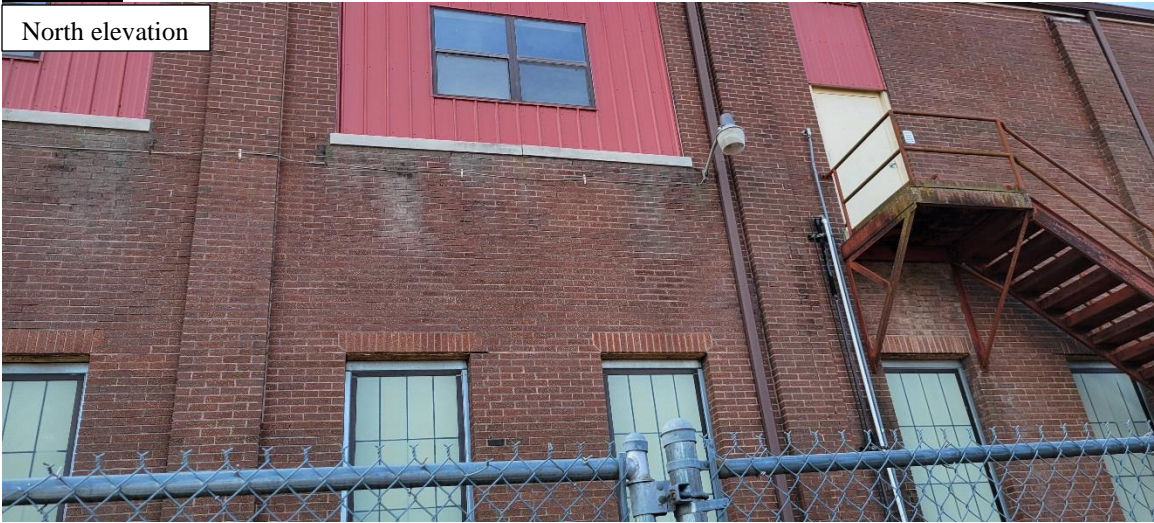
**Picture#7**

North elevation

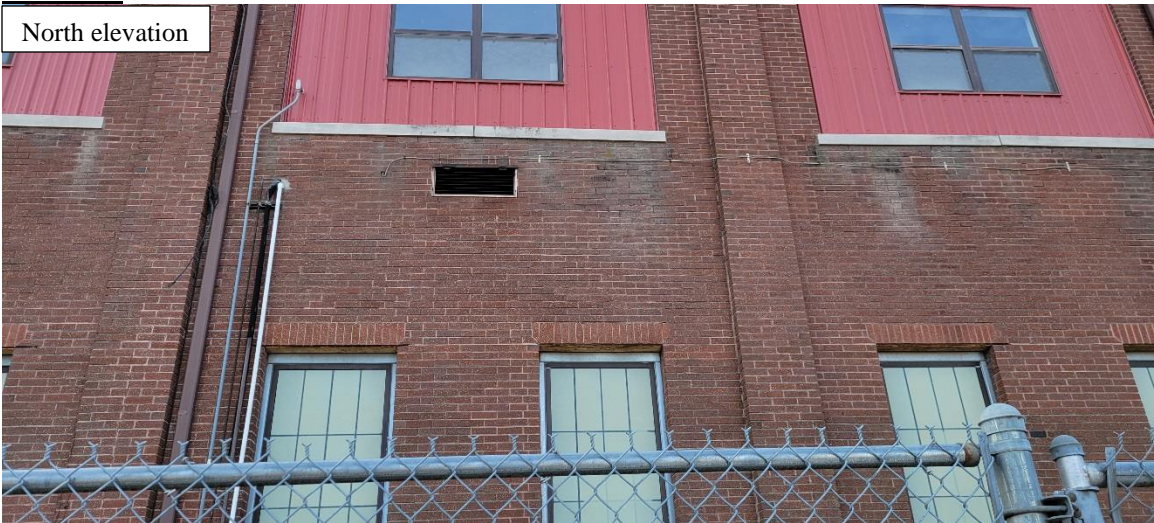
**Picture#8**

North elevation

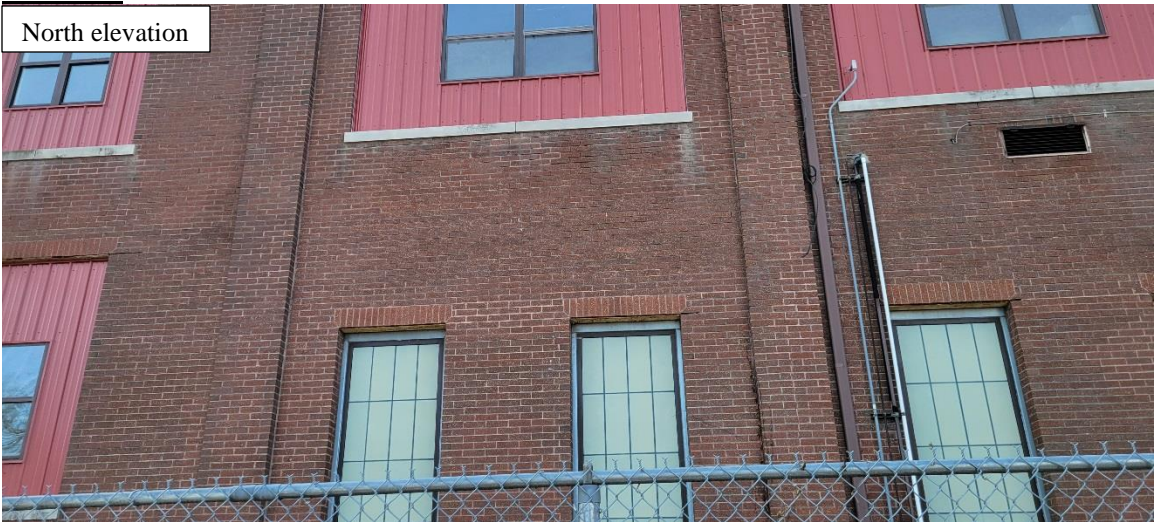
**Picture#9**

North elevation

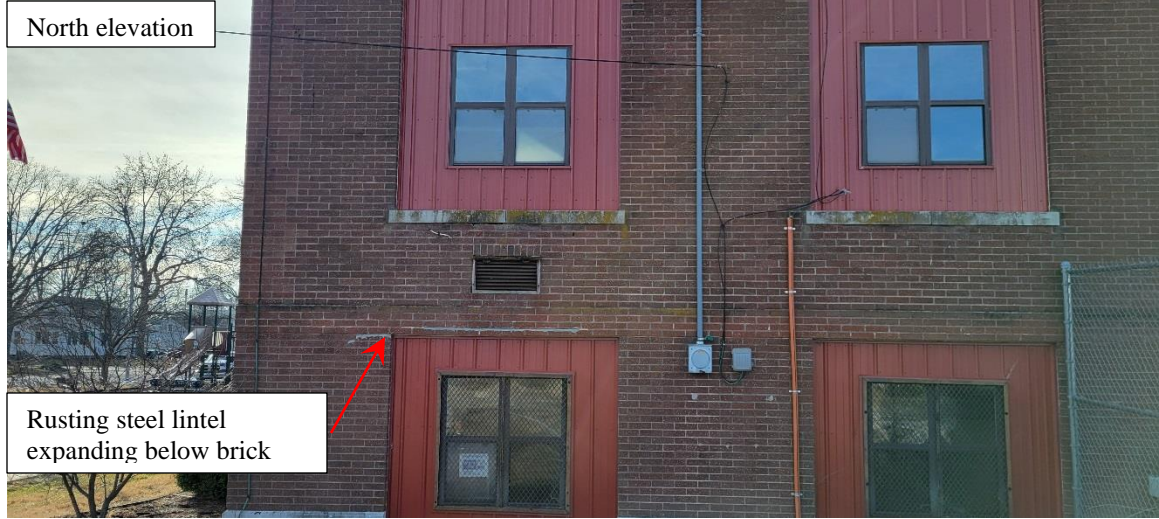
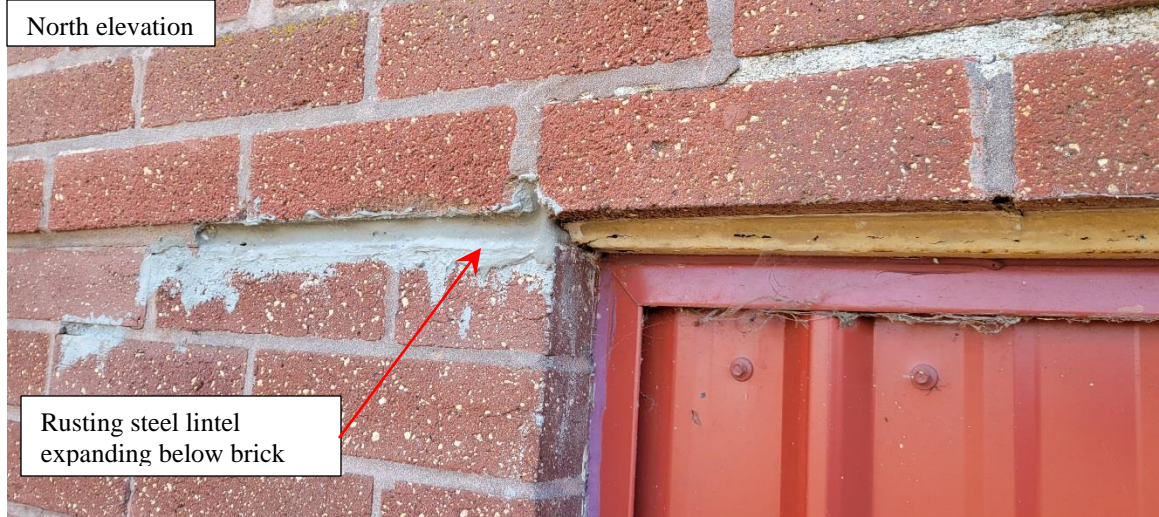
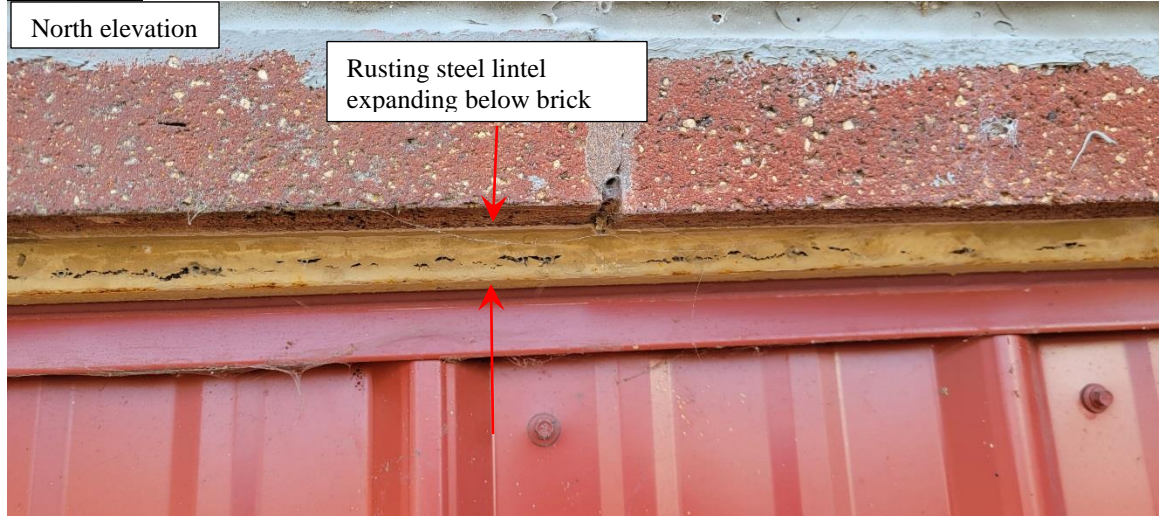
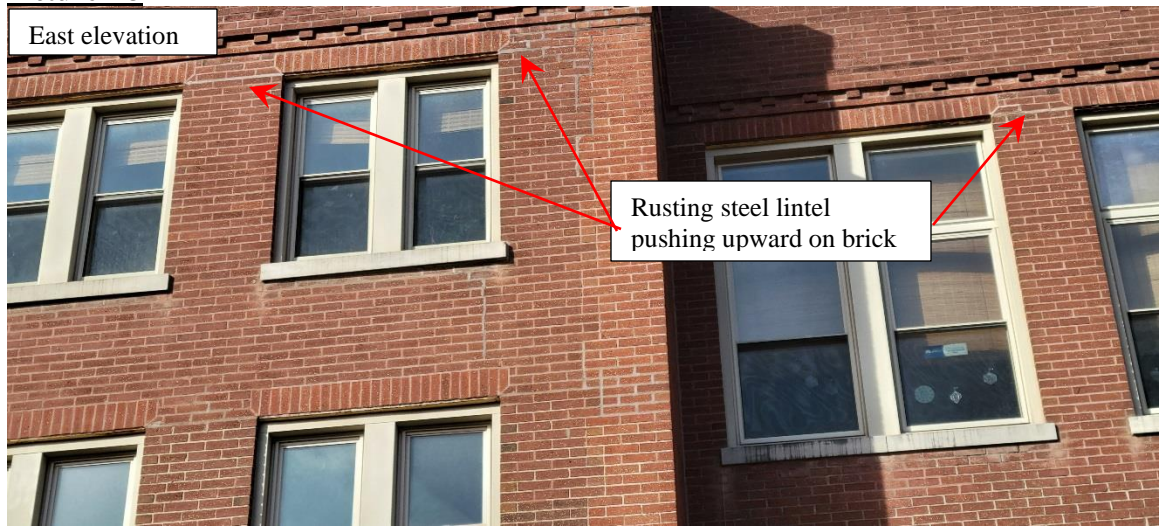
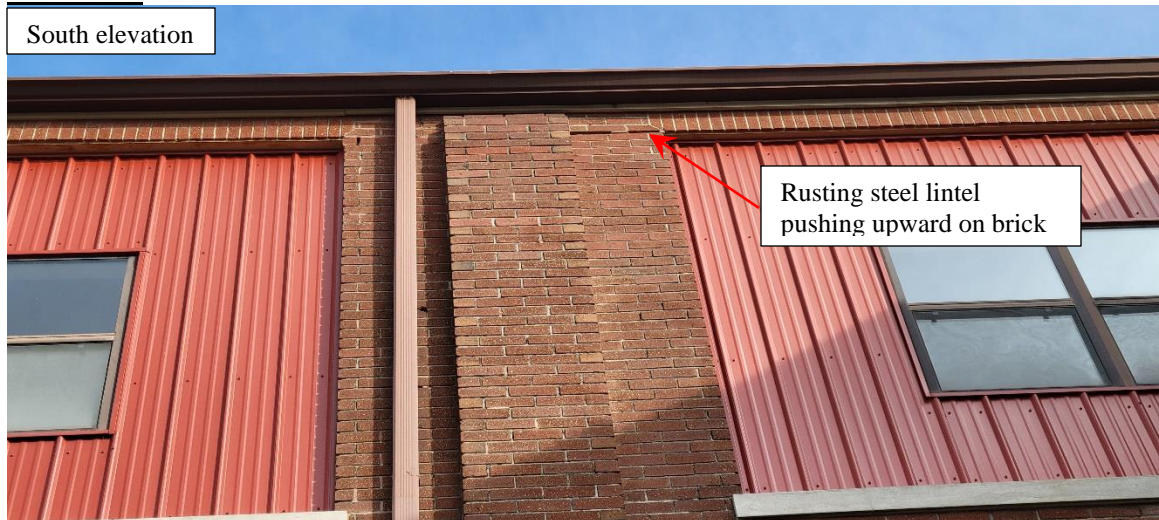
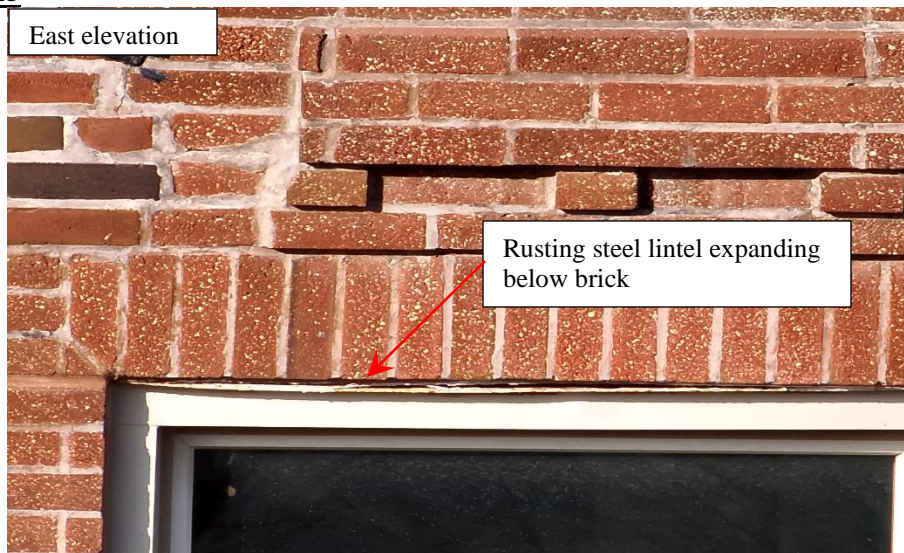
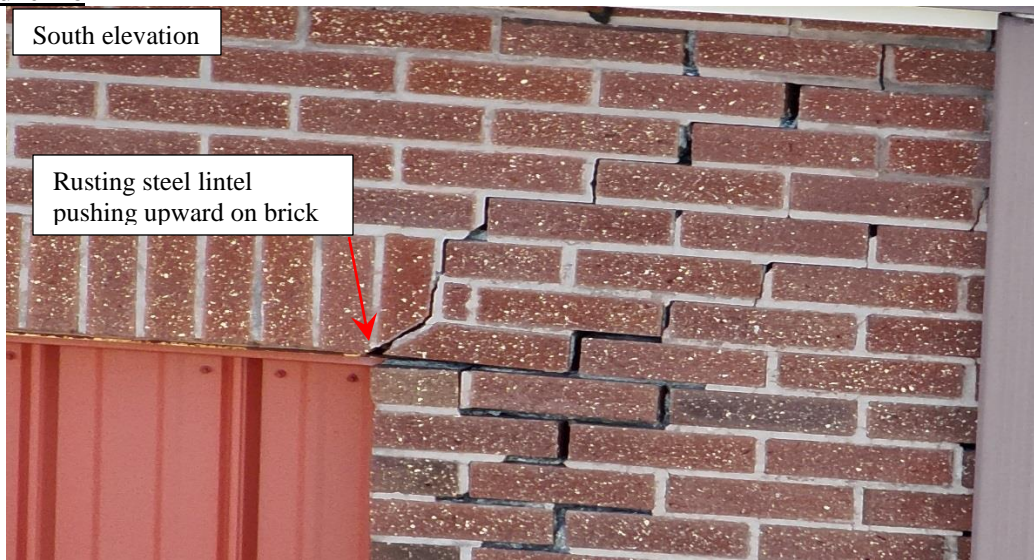
Steel lintels above window openings are beginning to expand due to the expansion of steel during oxidation (rusting). Evidence that the bearing ends have pushed the bricks upward resulting opening of the brick joints. **See Pictures #10 thru #16**

Exterior wall steel lintels were used to support the masonry wall over window openings. There is evidence that the steel lintels are oxidizing, and due to this rusting, the steel is expanding pushing up the brick upward causing brick joint to open. This oxidation also breaks down the load carrying capacity of the steel lintel.

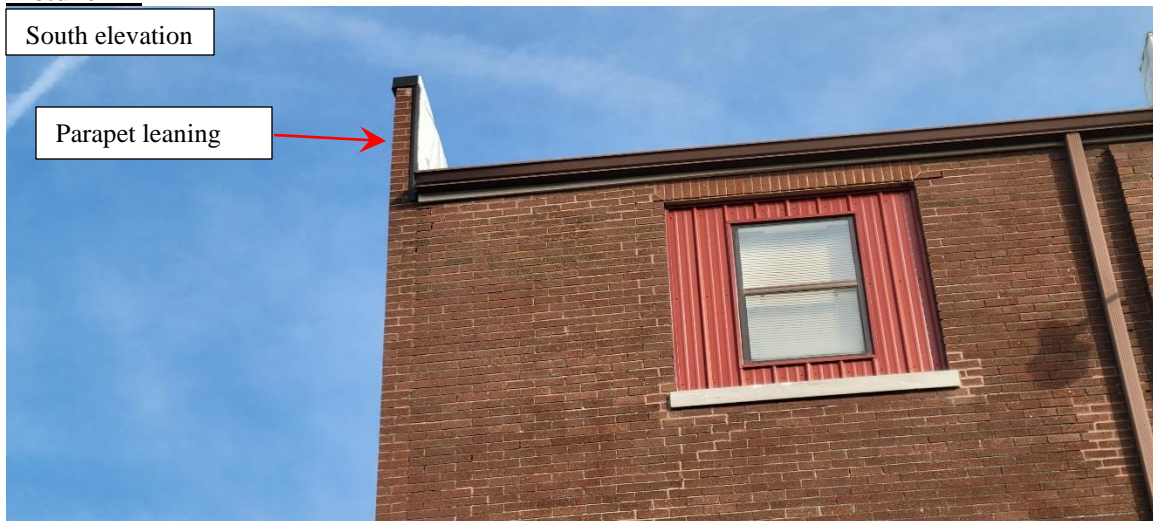
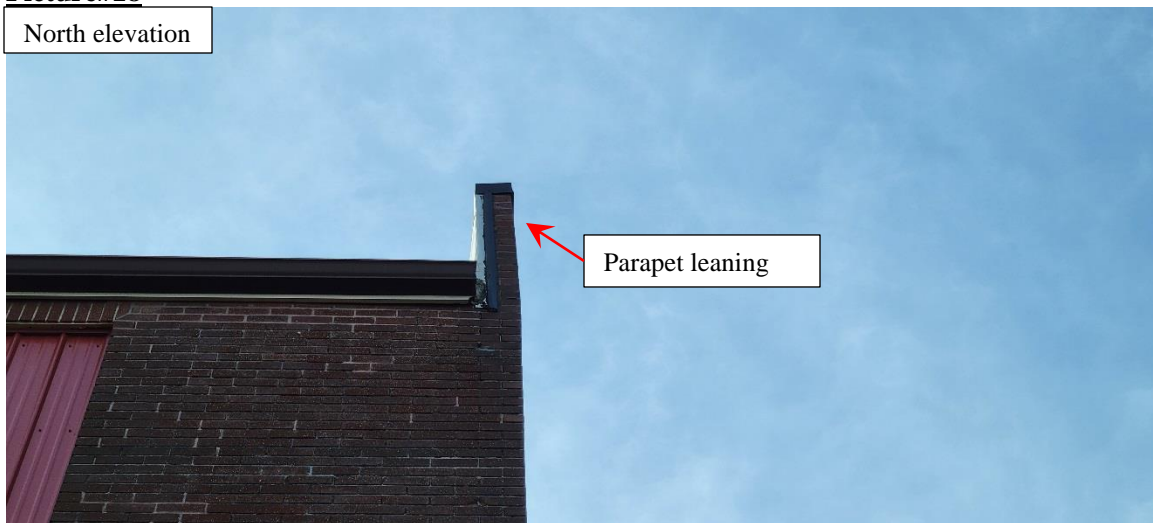
Parapet wall on the West wall (Gymnasium ) are starting to lean inward. **See Pictures #17 thru #18**

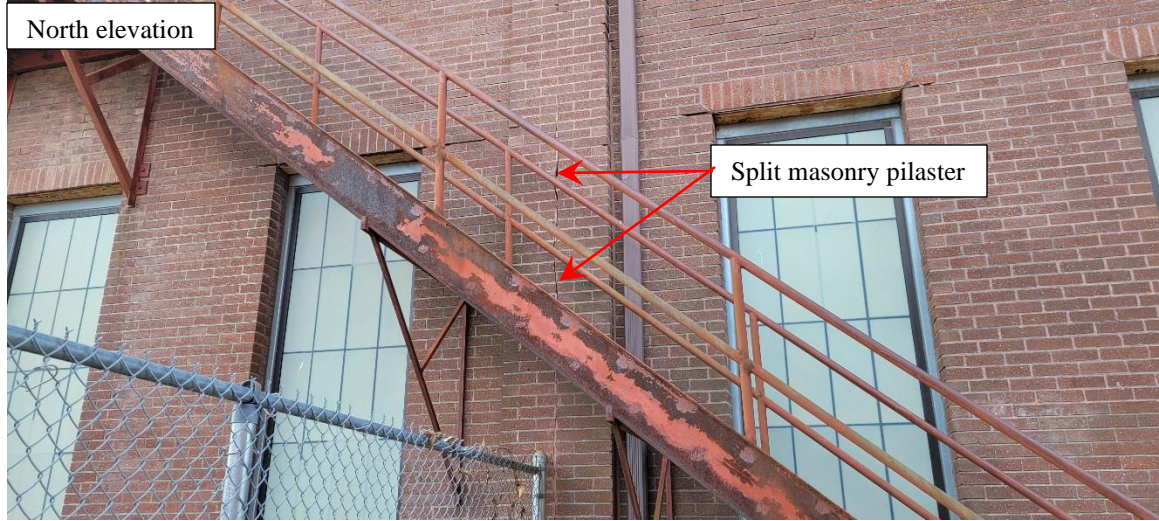
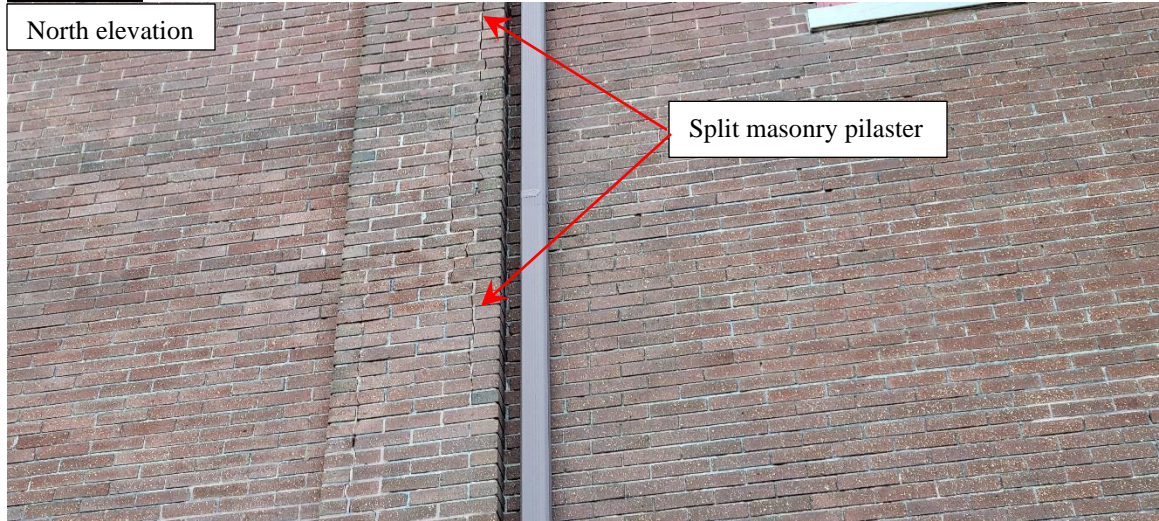
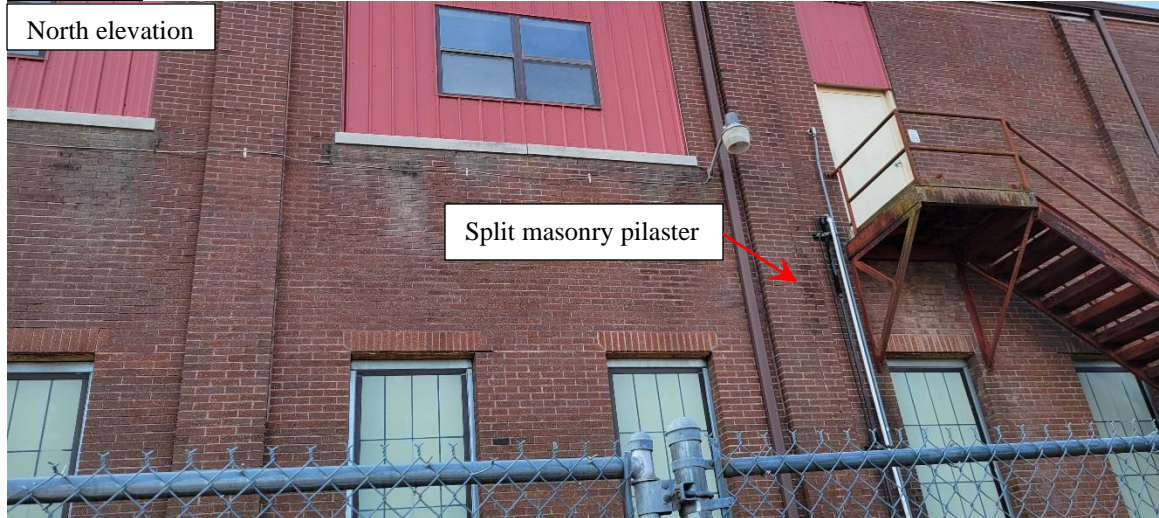
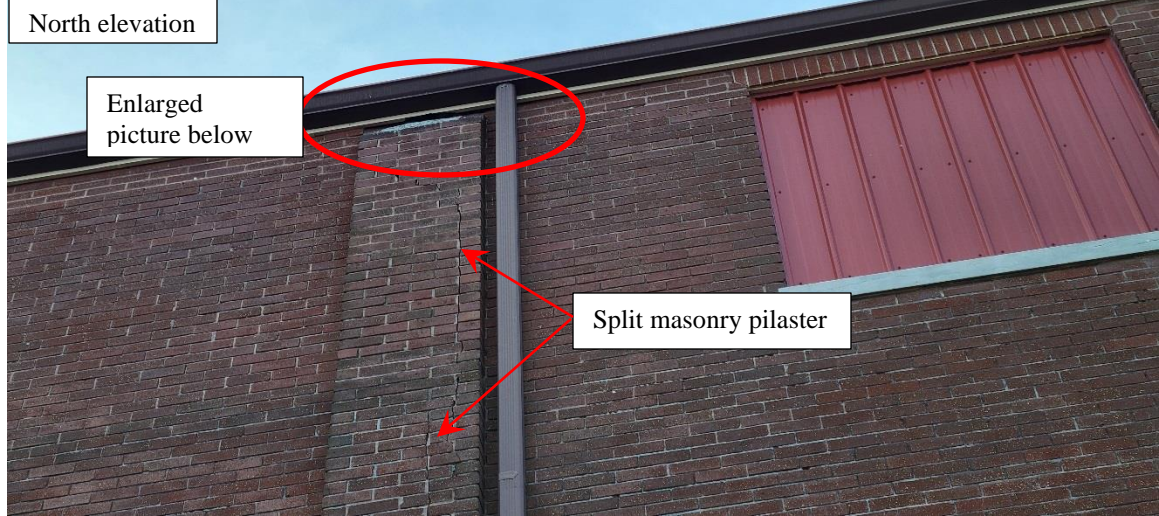
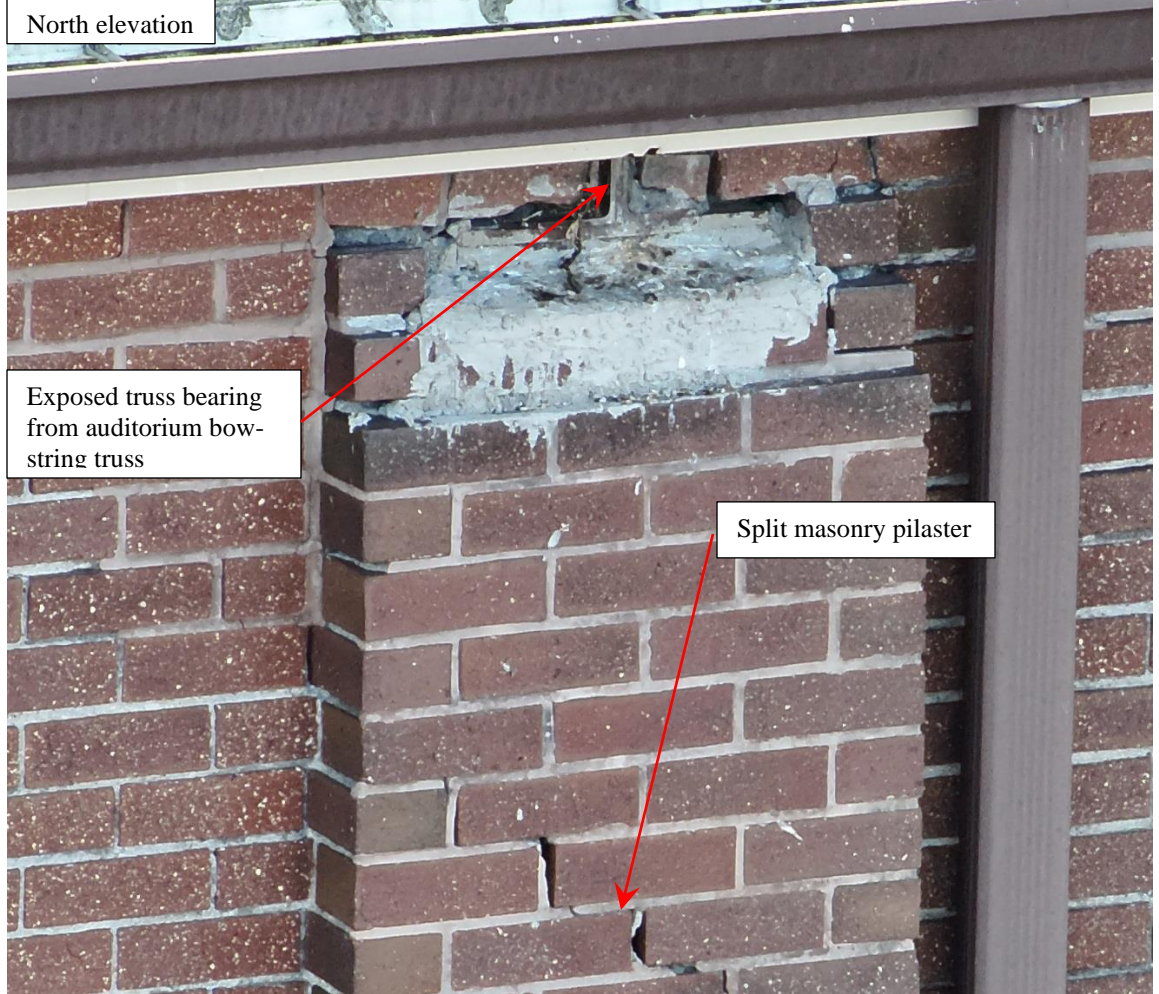
Along the North elevation the masonry pilasters are exhibiting vertical cracks. These pilasters align with the clear span beam that support the floor above, and the bowstring trusses that support the roof. 3 of the 4 pilasters on the North side exhibit these vertical cracks. It could not be determined if the pilaster encases a steel column or if the pilaster is completely made of masonry brick. (inner gym wythe is a glazed tile) **See Pictures #19 thru #23**

The North face consist of pilasters which supports a clear-span bowstring truss and a clear span floor beam above the gymnasium space. These clear span supports creates a high concentration force. 3) of the 4) pilasters are failing through evidence of the vertical fractures. It was unattainable to identify if there was a steel column encapsulated inside the pilaster and the columns is expanding from oxidation or if moisture from freeze/thaw has created the cracks. Either condition, these pilasters shall be considered incapable to support the roof truss and floor beams when fully loaded.

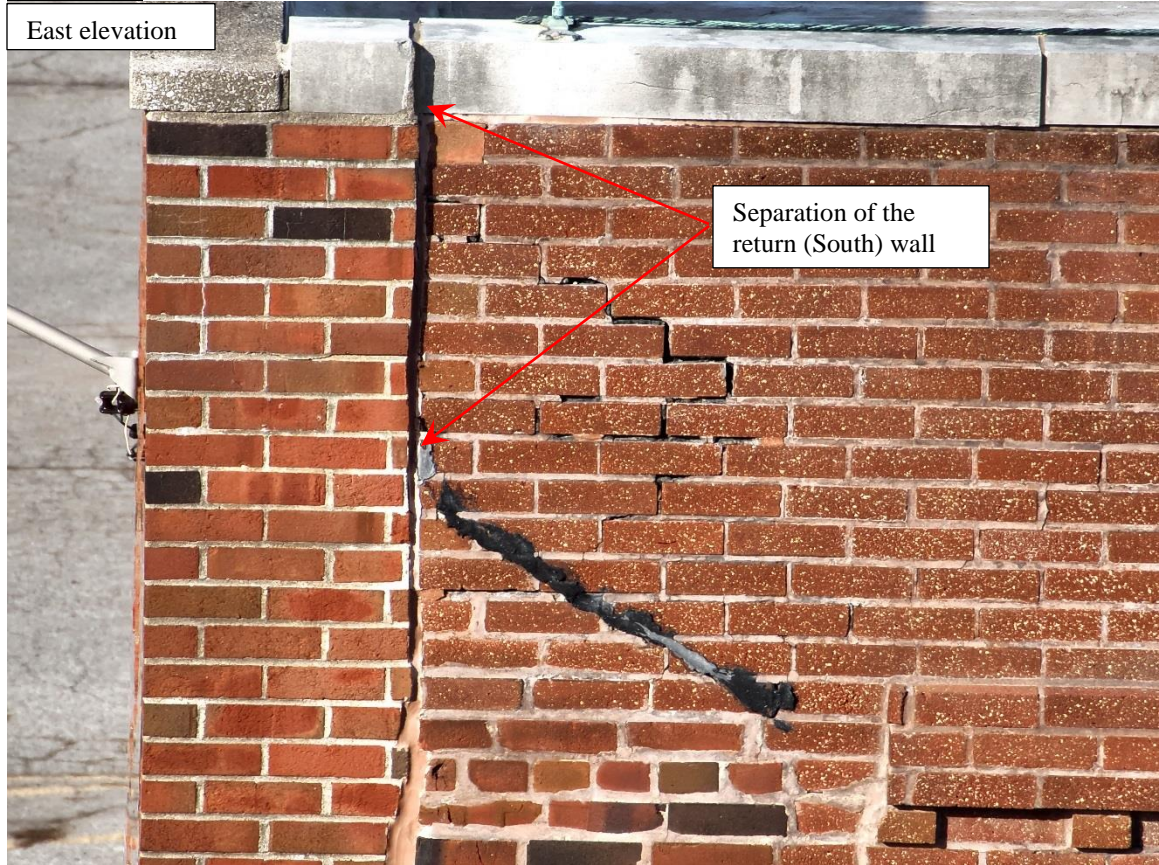
**Picture#24**

The original structure had an addition built to the south of the front elevation. This addition was removed due to causes of mine subsidence. A new masonry mutli-wythe masonry was added to close off the south wall. This new wall is showing signs of separation between the new and existing structure. **See Pictures #24 thru #24.**

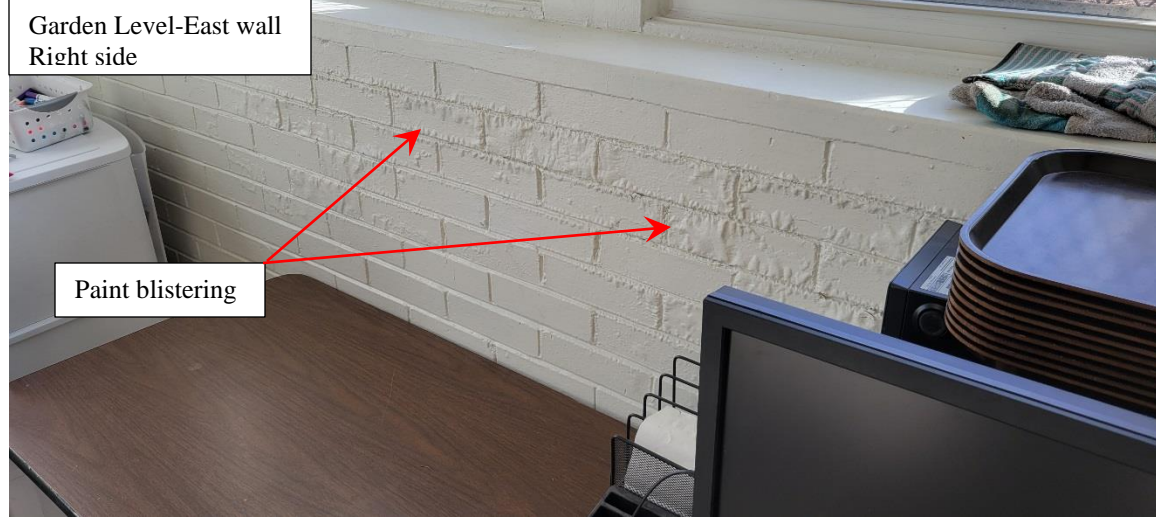
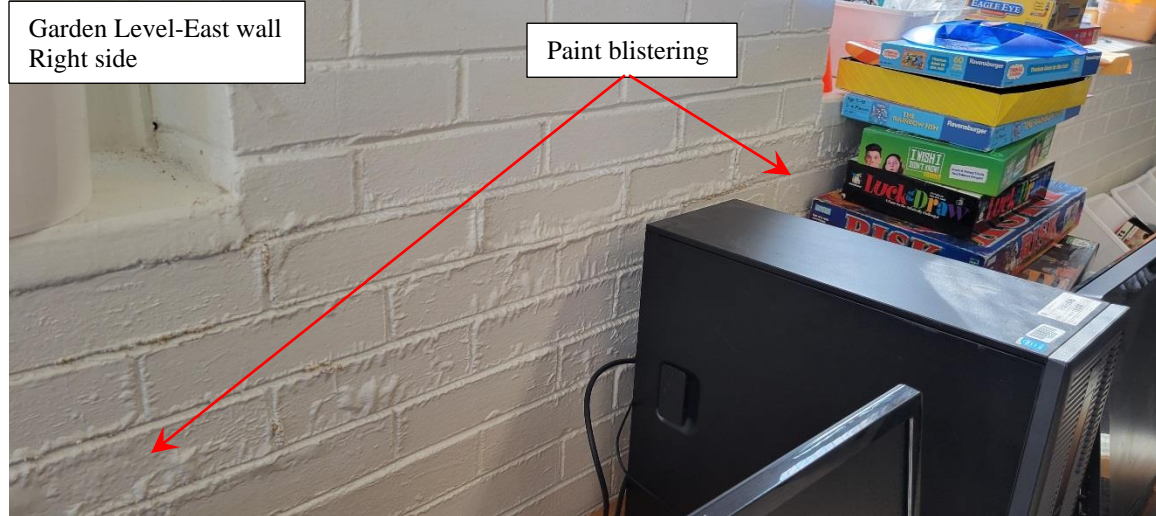
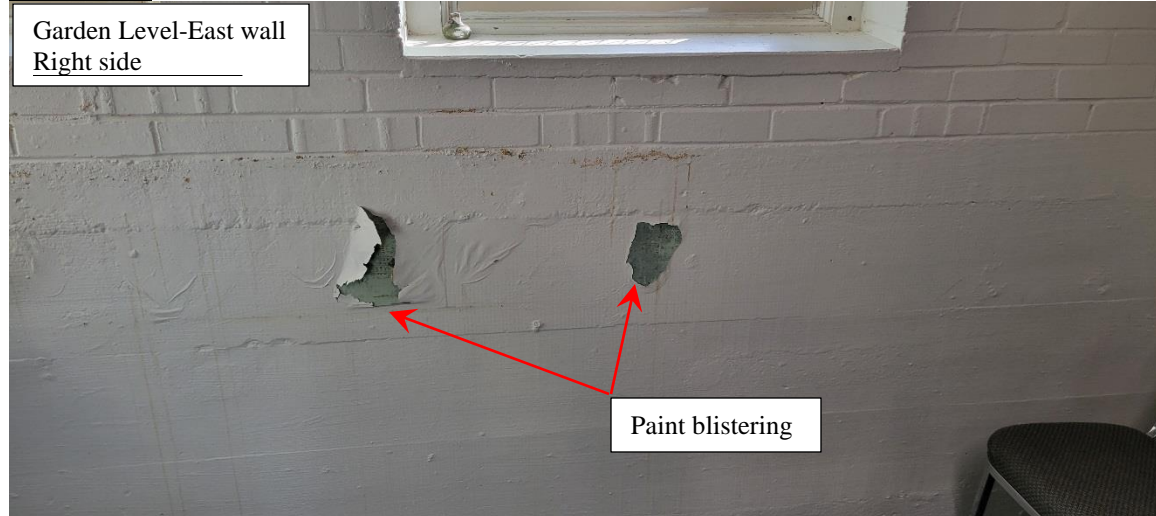
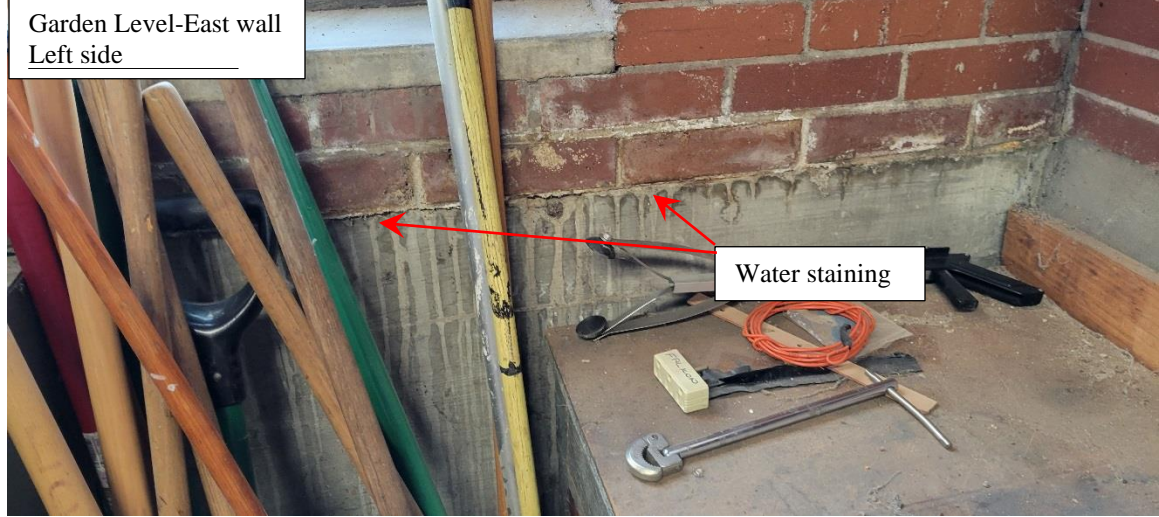
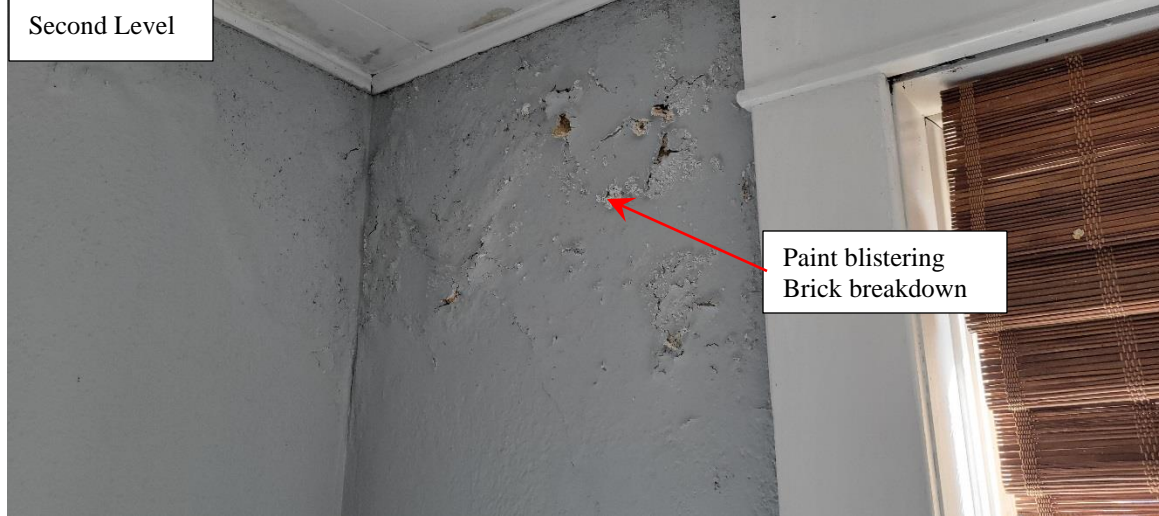
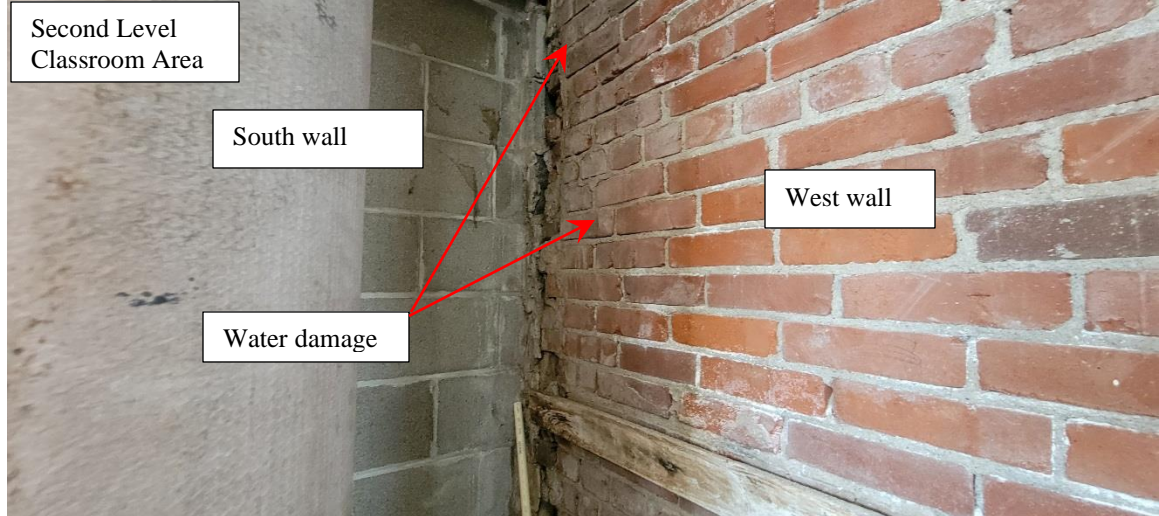
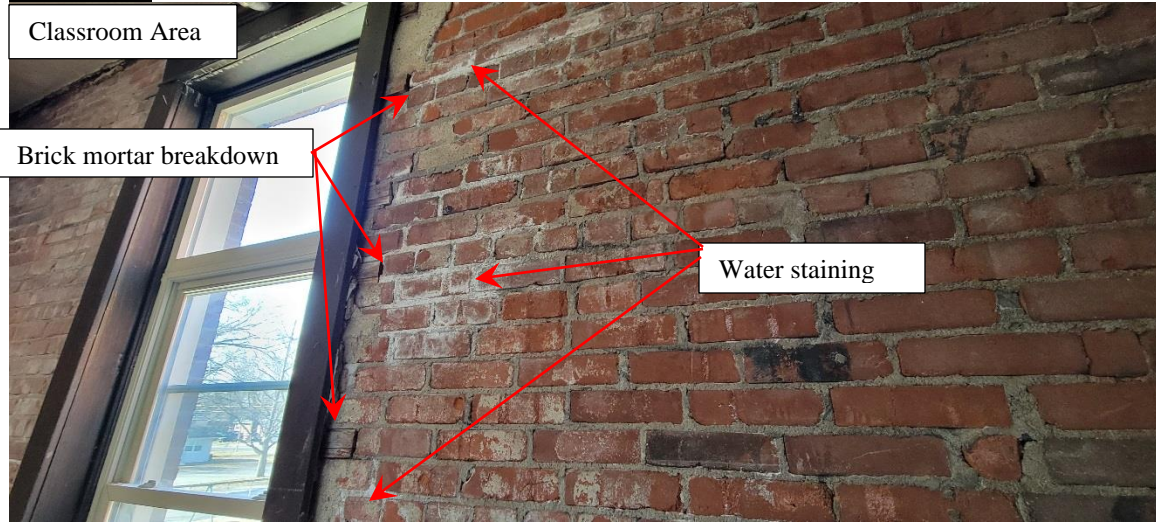
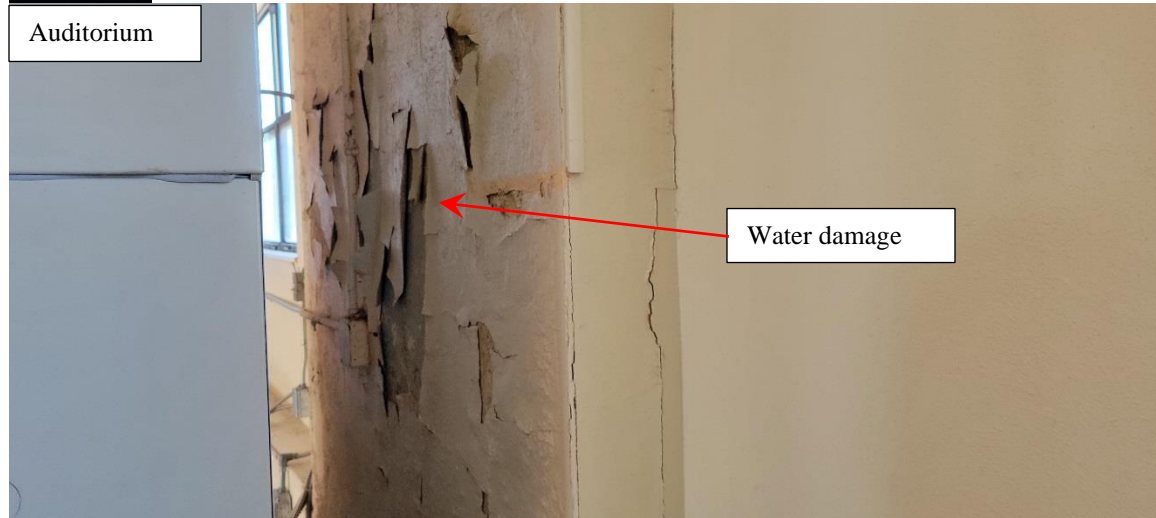
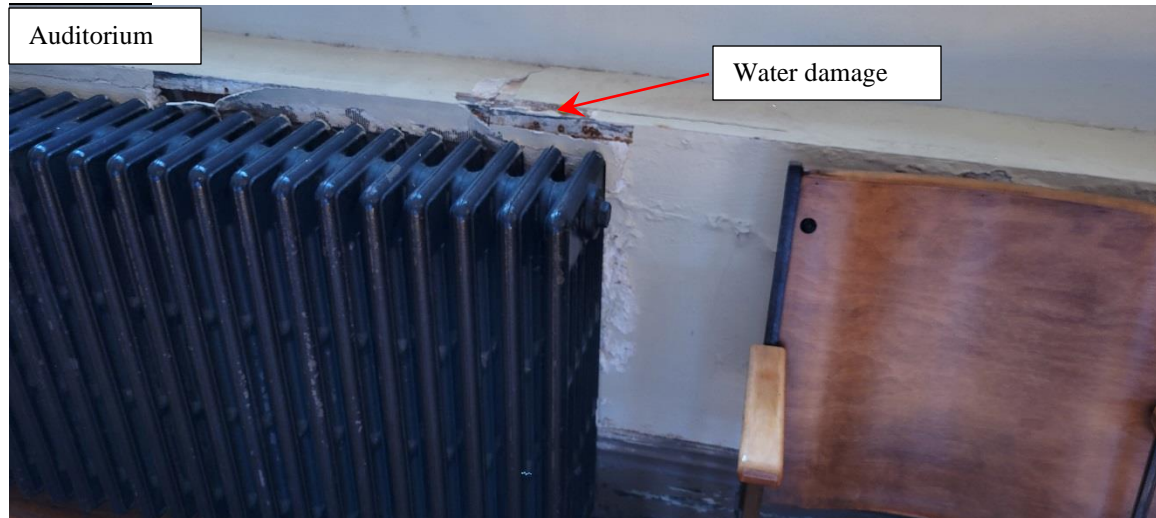
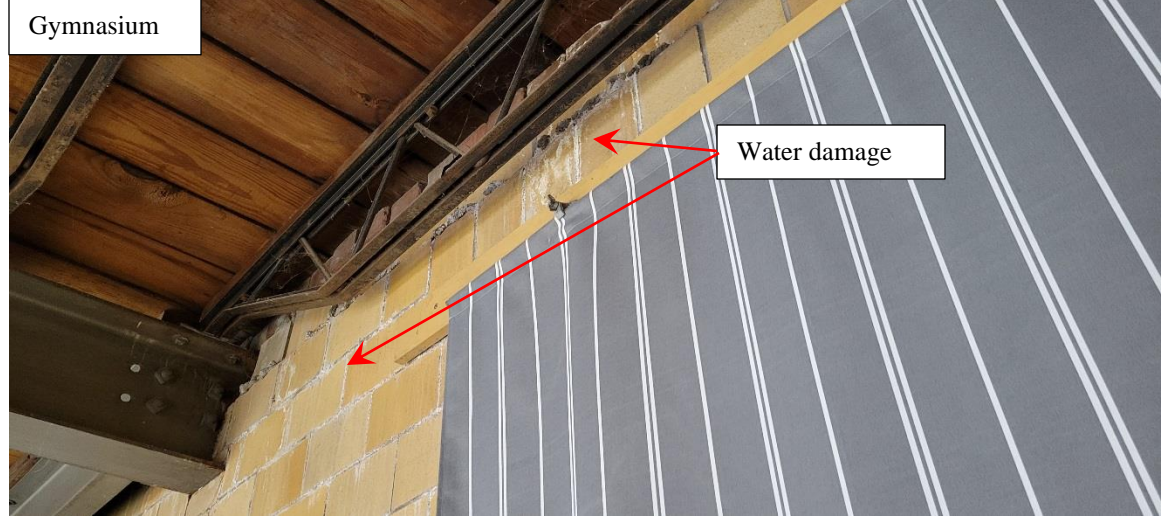
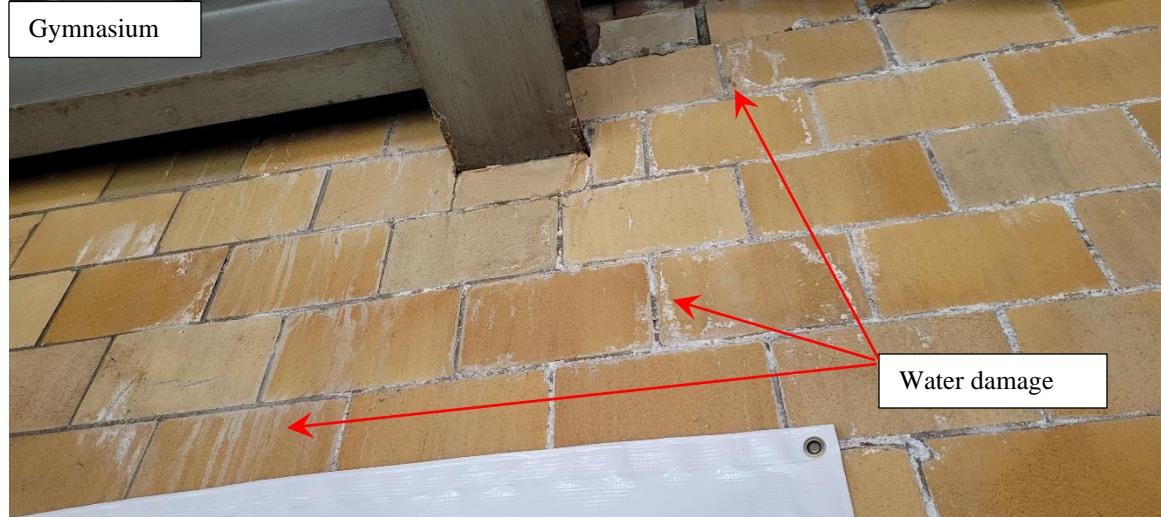
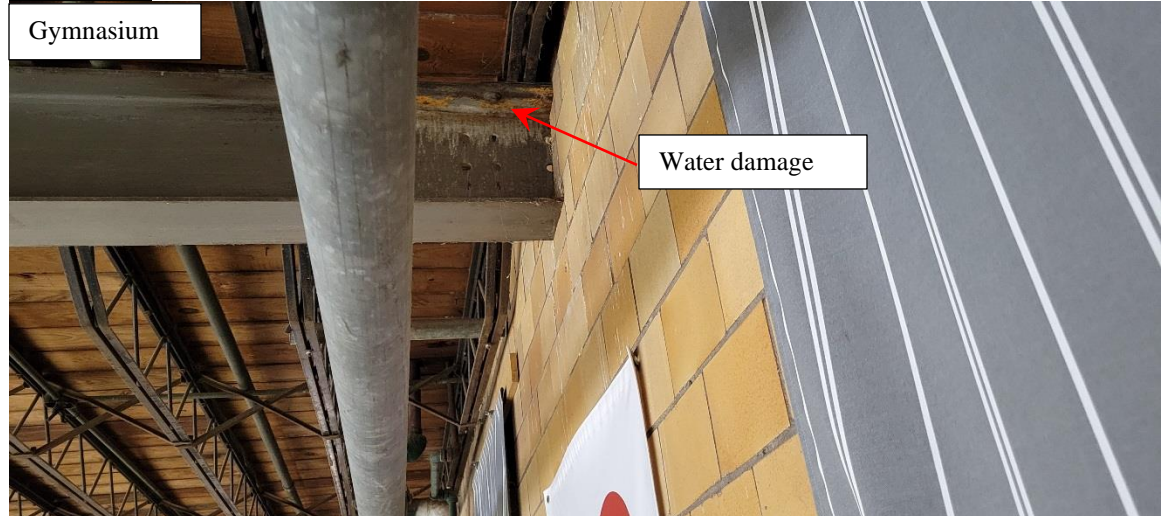
Evidence of water entering the building. There are multiple areas where it was noticed that water is entering the building from the exterior of the building envelope. Interior wall paint is blistering from water trapped between the brick and paint. Water stains are noticed where the exterior walls are unpainted. Noticeable break down of the interior mortar joints. **See Pictures #26 thru #37.**

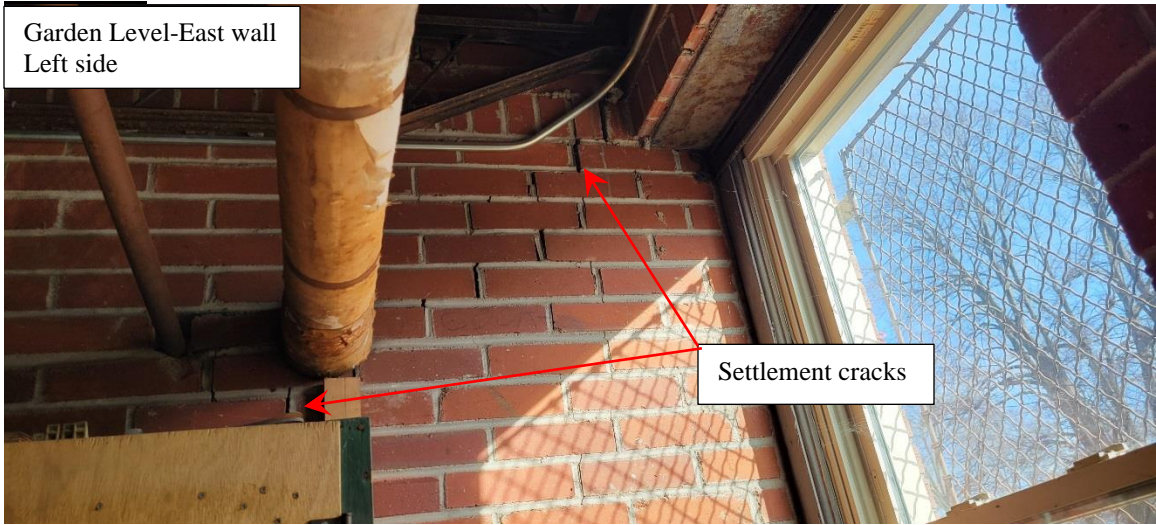
**Picture #38**

Multiple areas were noted having stress cracks in the interior masonry and light framed plastered walls. Diagonal fractures are prevalent throughout the classroom areas on all three levels of the building. A vertical crack (picture #43) was observed in the auditorium north wall which aligns with the exterior pilaster which also exhibits vertical cracks on the exterior. **See Pictures #38 thru #43.**

Garden Level-East wall  
Left side

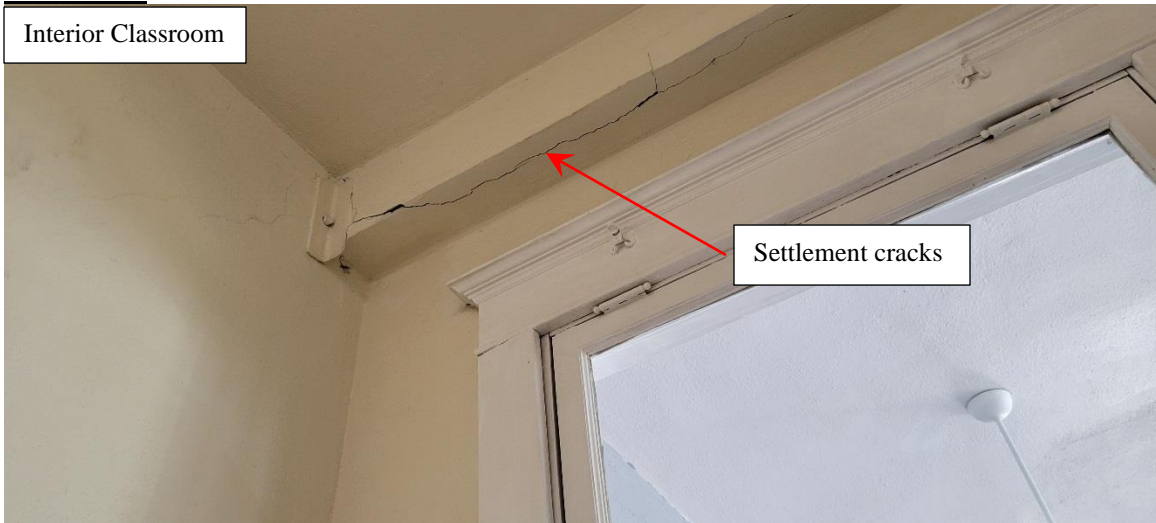
**Picture #39**

Interior Classroom
