**Building Assessment Report**

Feb 28, 2026

Ref: Leu Civic Center  
213 N. Market St  
Mascoutah, IL

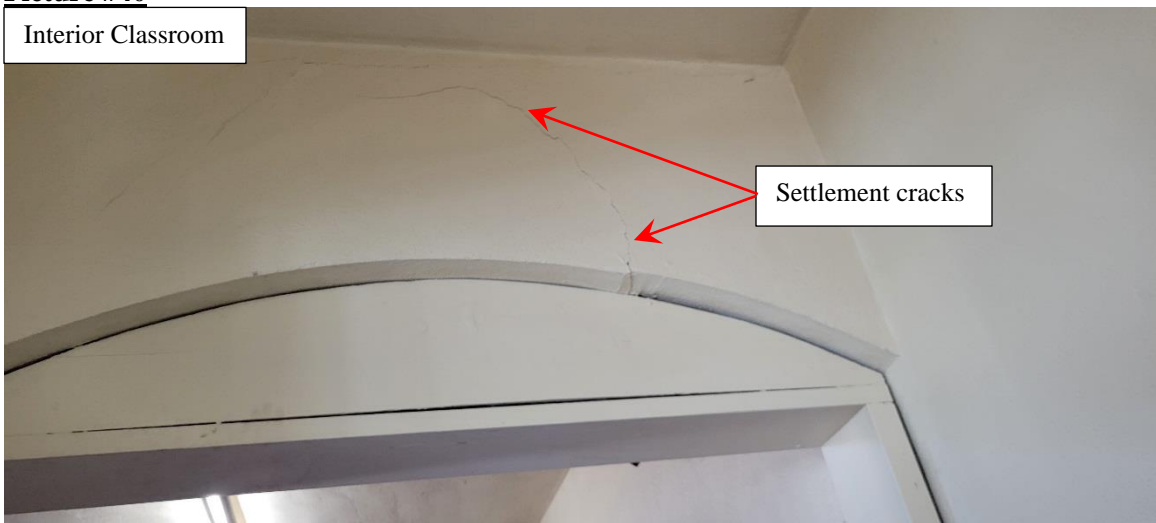
**Picture #40**

Multiple areas were noted having stress cracks in the interior masonry and light framed plastered walls. Diagonal fractures are prevalent throughout the classroom areas on all three levels of the building. A vertical crack (picture #43) was observed in the auditorium north wall which aligns with the exterior pilaster which also exhibits vertical cracks on the exterior. **See Pictures #38 thru #43.**

Interior Classroom

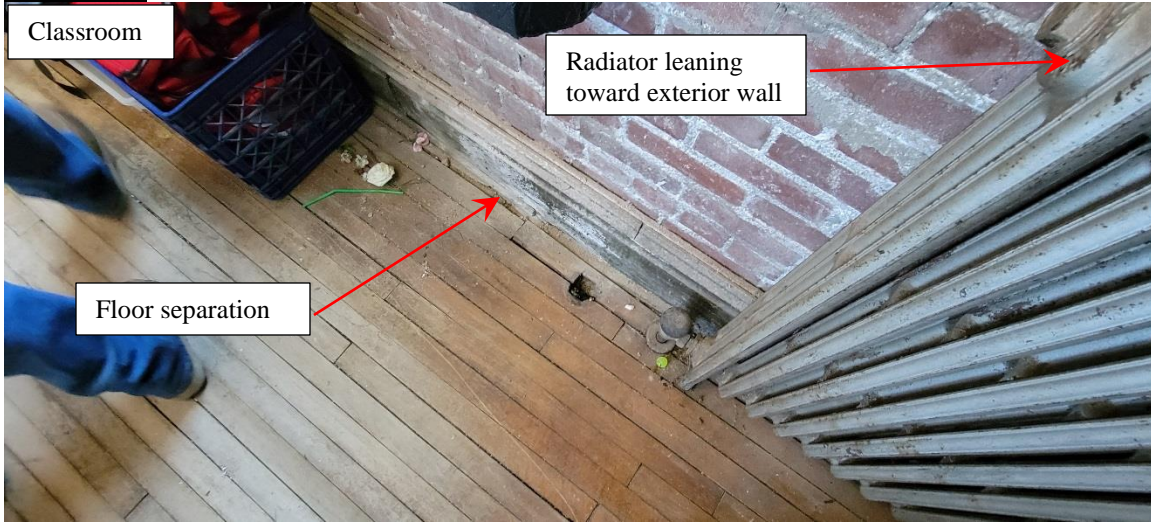
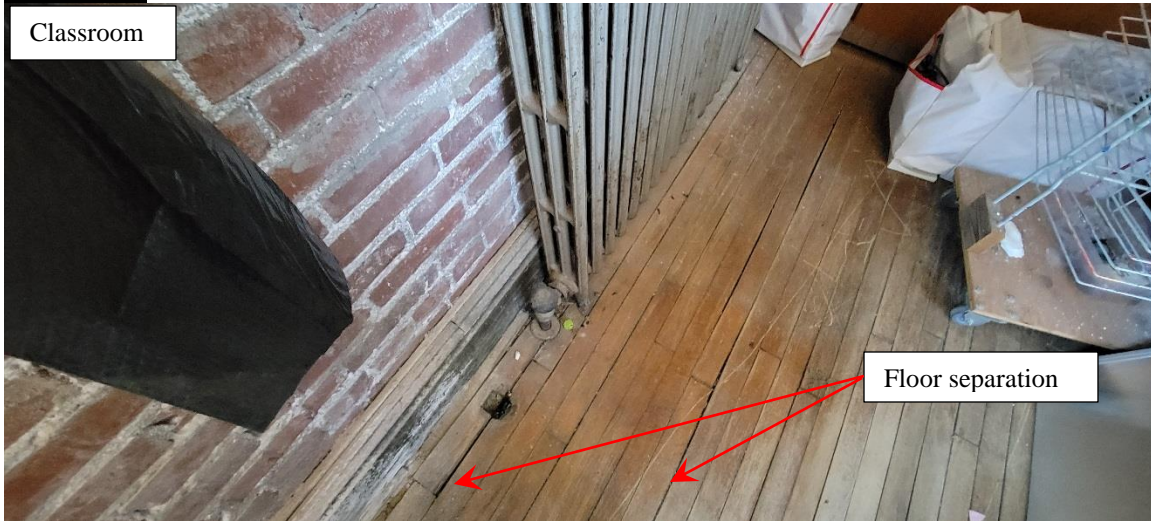
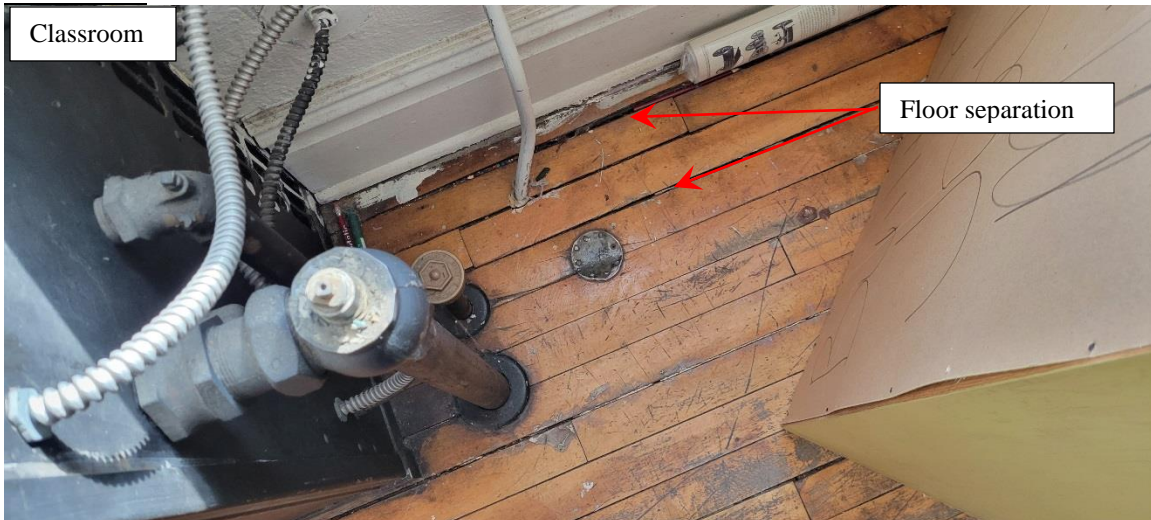
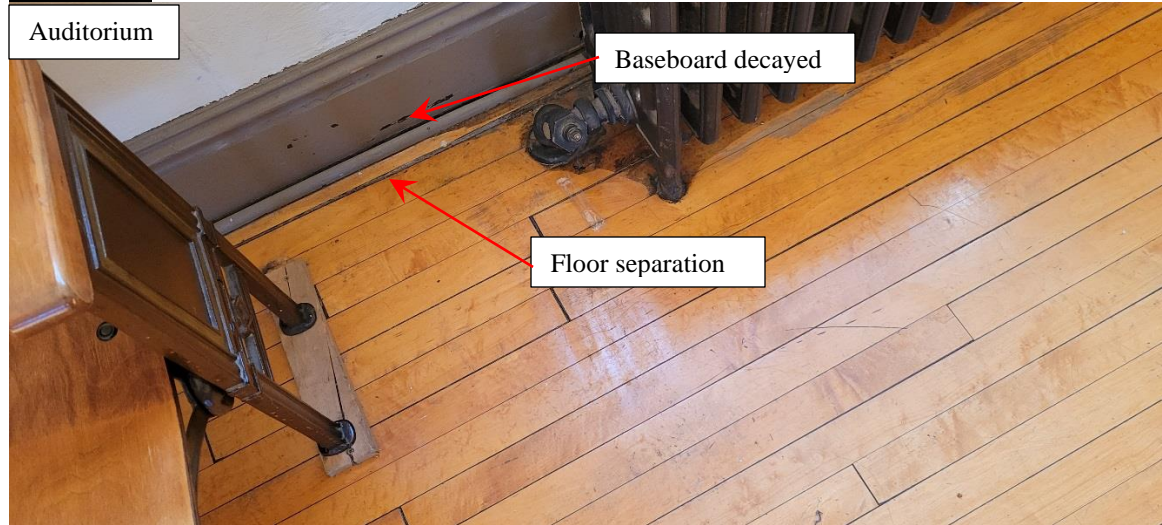
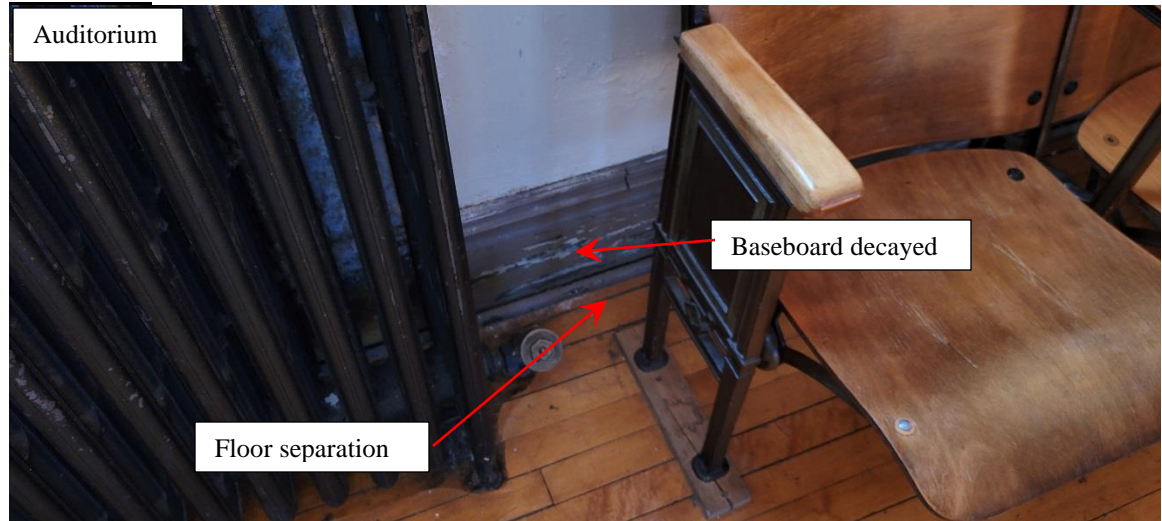
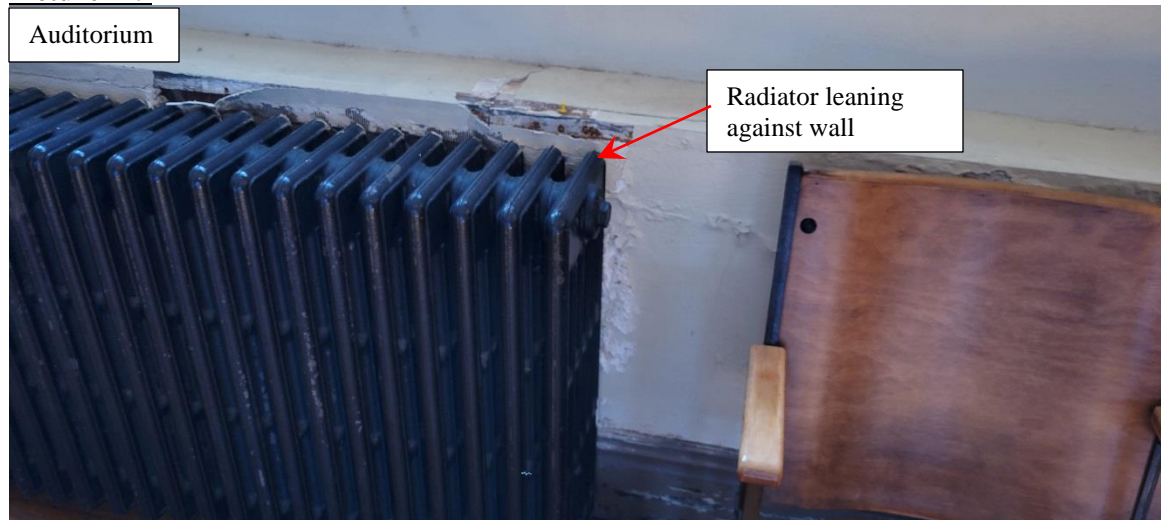
Floor framing along the exterior walls are showing signs of separation. Slight foot pressure on the floor responds with movement. Most of the floor separations are near the radiators. Additionally, the radiators are leaning towards the exterior wall. **See Pictures #44 thru #49**

The last concern due to the affects of water is the connection of the floor joist(floor diaphragm) to the exterior wall. Several locations there is evidence of the wall separating from the floor diaphragm. Moisture in the masonry wall is breaking down the wood joist that bear in the in the masonry wall. The interaction between the joist and the wall is very crucial in the stability of the wall. When the joist ends no longer maintains the capability to tie the wall to the floor diaphragm, the walls become unstable under any type of winds loads or seismic loads. This same concept applies to the roof framing (roof diaphragm).
