**Building Assessment Report**

Feb 28, 2026

Ref: Leu Civic Center  
213 N. Market St  
Mascoutah, IL

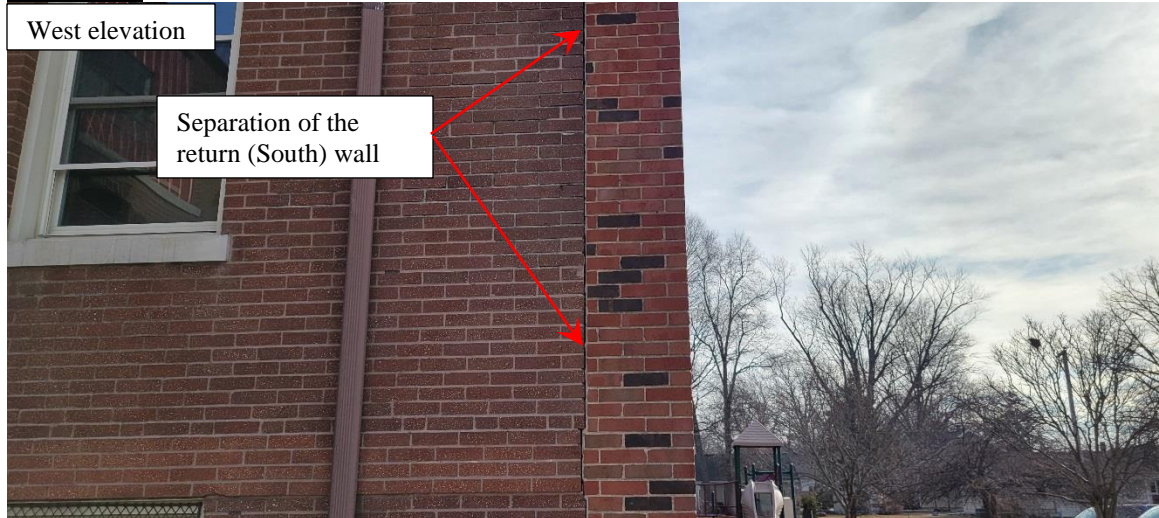
**Picture #26**

Evidence of water entering the building. There are multiple areas where it was noticed that water is entering the building from the exterior of the building envelope. Interior wall paint is blistering from water trapped between the brick and paint. Water stains are noticed where the exterior walls are unpainted. Noticeable break down of the interior mortar joints. **See Pictures #26 thru #37.**
